INFRASTRUCTURE, PLANNING AND ENVIRONMENT COMMITTEE

13 JULY 2023

REPORT: Benolong Bridge - Temporary Load Limit Due to Timber Bridge Condition

Dubbo Regional Council
Benolong Bridge
Level 2 Inspection Report

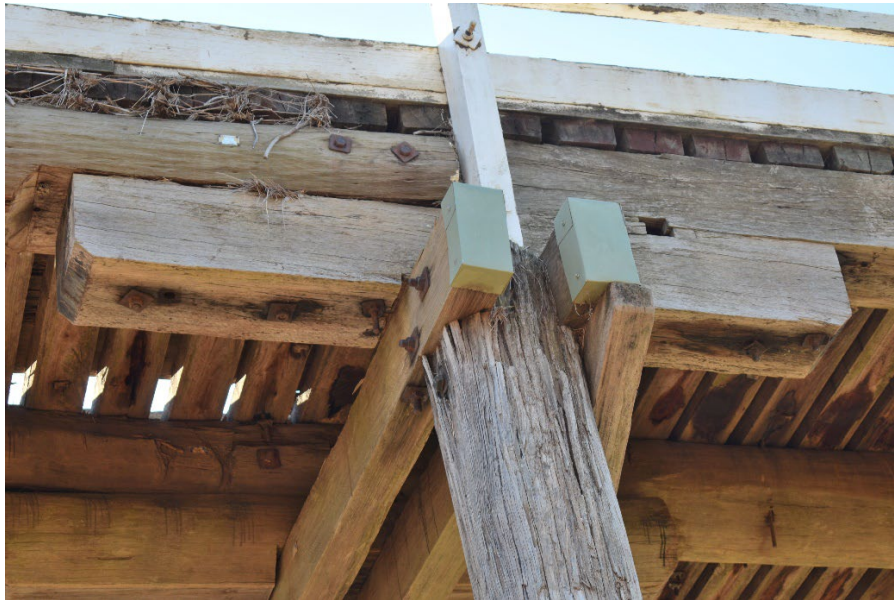
Figure 3-1 Old (original) square corbel element (Source: FBE)

There is evidence that the bridge has been renewed at some point in the past. Most of the superstructure, including girders, deck and corbels, were replaced. It is believed that some original elements of the bridge including corbels and girders were left in place. They were probably assessed as being in good condition and still acceptable as structural members. There are no drawings or other information to confirm more details like element sizes and timber grades. *Figure 3-1* shows an example of the old (original) corbel element, *Figure 3-2* presents a new corbel element and *Figure 3-3* shows an old (original) and new girder beams.

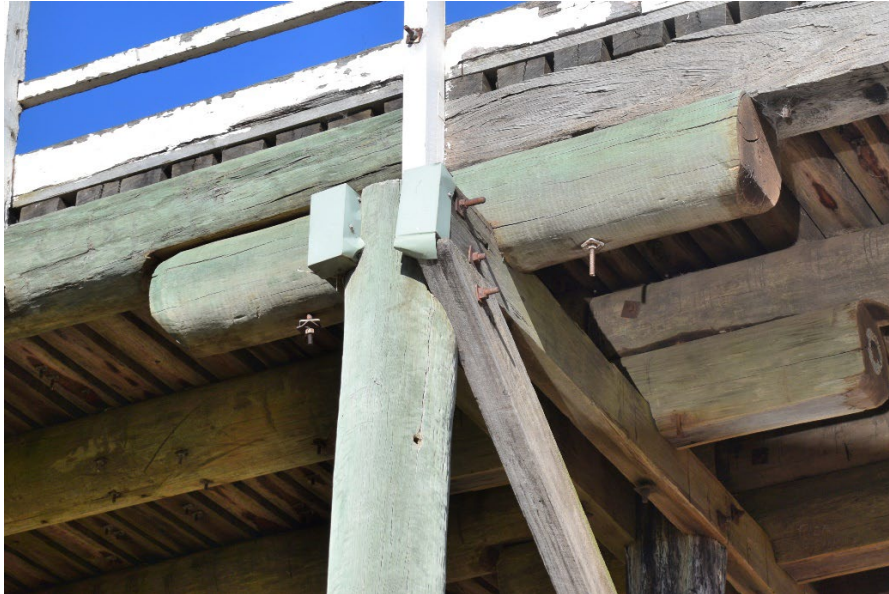
Figure 3-2 New corbel element (Source: FBE)

The new round corbels appear to be copper chrome arsenate (CCA) treated to prevent insect and fungal attacks.

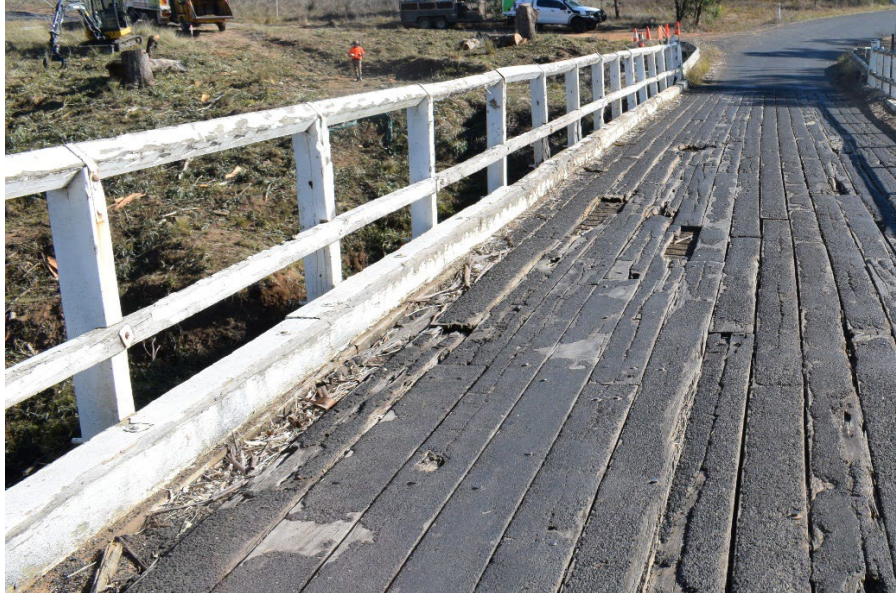
Figure 3-4 Typical barrier and kerb (Source: FBE)

There is a non-compliant timber ordinance barrier on each side of the deck bolted to the edge girders and kerbs (see *Figure 3-4*). The carriageway kerbs are formed of square timber sections seating directly on top of the timber deck planks. Both the kerbs and barriers had evidence of minor paint loss and debris accumulation along kerb lines. There is possibility of white lead used in paint material which should be considered as a possible hazard (i.e. during demolition or repairs).

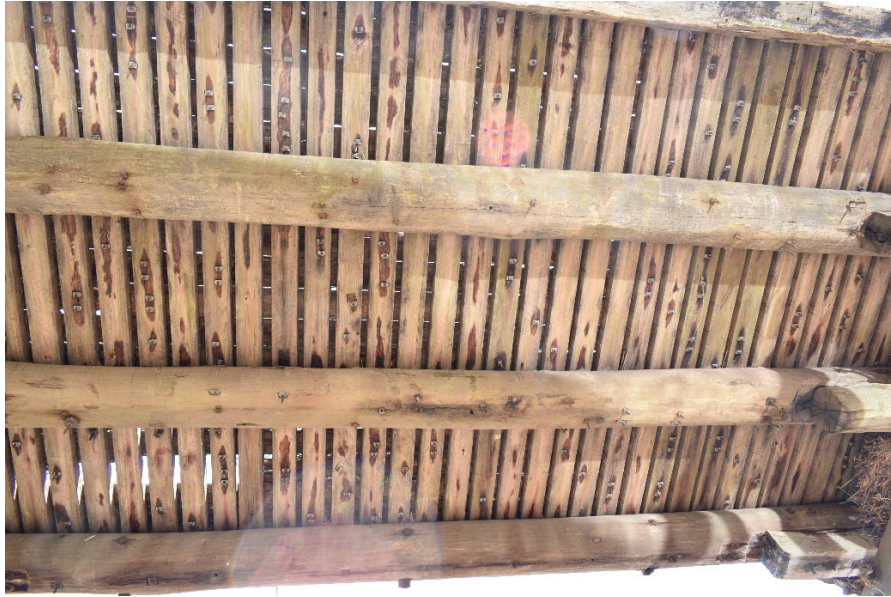
Figure 3-5 Transverse planks, typical condition (Source: FBE)

Transverse planks were found to be in fair condition (see *Figure 3-5*) with some isolated areas being heavily decayed, especially at Span 1 (see *Figure 3-6*).

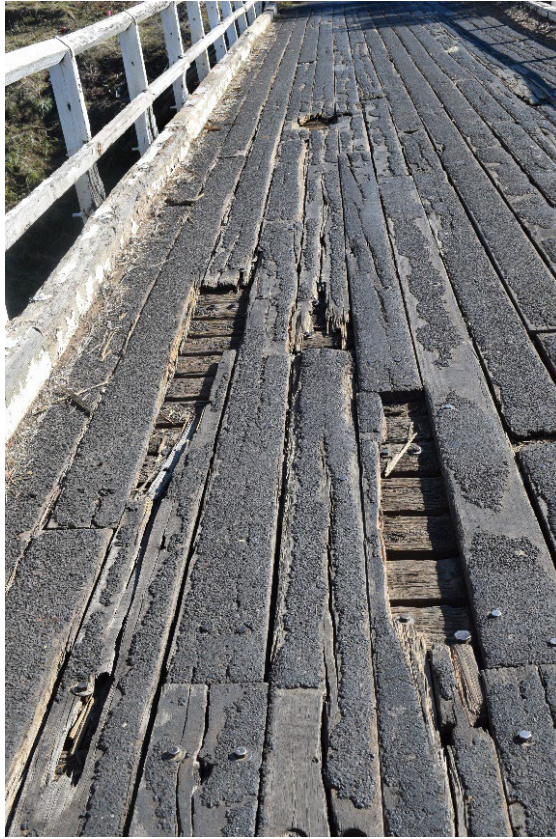
Figure 3-7 Typical top of deck condition (Source: FBE)

There were numerous locations of running planks being damaged with evidence of full section loss resulting in holes, loose and moving elements of the deck (see *Figure 3-7*).

It was observed that many of the deck bolts connecting the running planks to transverse timber planks were untightened and loose with characteristic sound of rattling when vehicles were crossing the bridge.

- Replace decayed brace at Pier 1.
- Replace decayed and missing longitudinal deck timber sheeting.

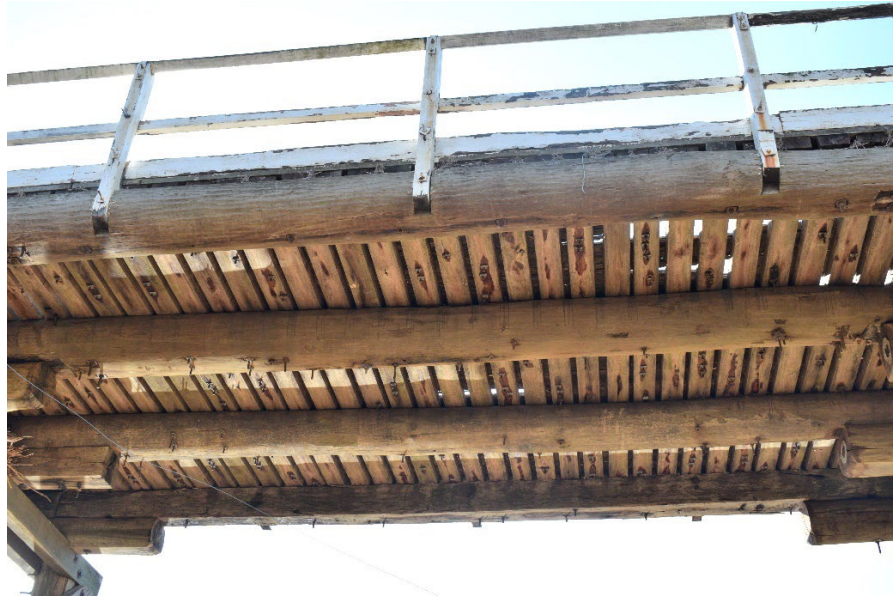
Figure 3-8 Superstructure soffit, typical condition (Source: FBE)

All girders were found to be in a fair to good condition with the original square beams to be slightly worse, having evidence of surface weathering, and some splitting. *Figure 3-8* shows the typical superstructure condition and *Figure 3-9* a typical square girder.

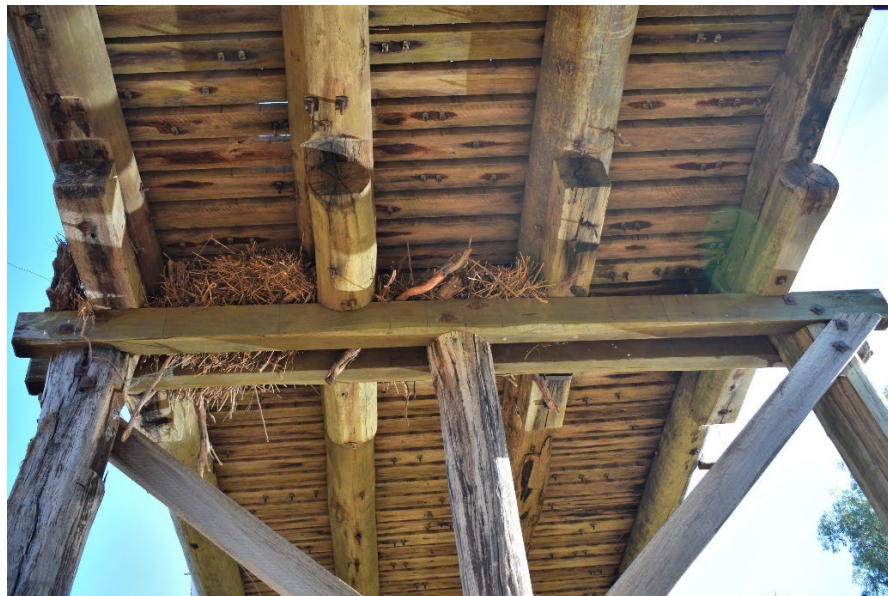
Figure 3-10 Corbels - typical condition - note flood debris (Source: FBE)

The corbels were also found to be in fair to good condition (see *Figure 3-10*) and a few corbel bolts connecting the corbels and girders were found loose (see *Figure 3-11*).

- Tightening of loose bolts.
- Remove debris from the carriageway.
- Remove flood debris build-up at piers.

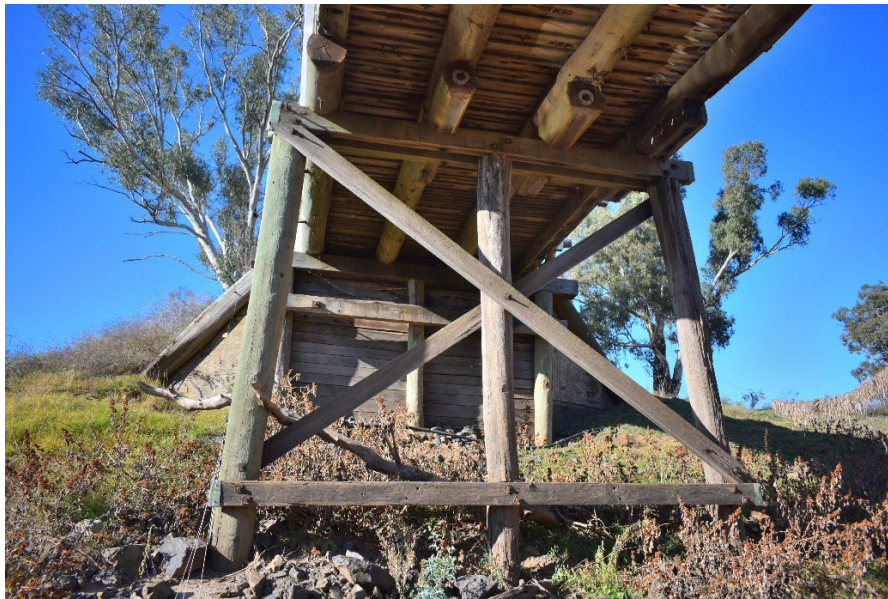
Figure 3-12 Typical trestle support (Source: FBE)

The trestles comprised of capwales supported by central vertical pile and outer raked piles with diagonal braces seated on bottom double sills were found to be between fair and poor condition (see

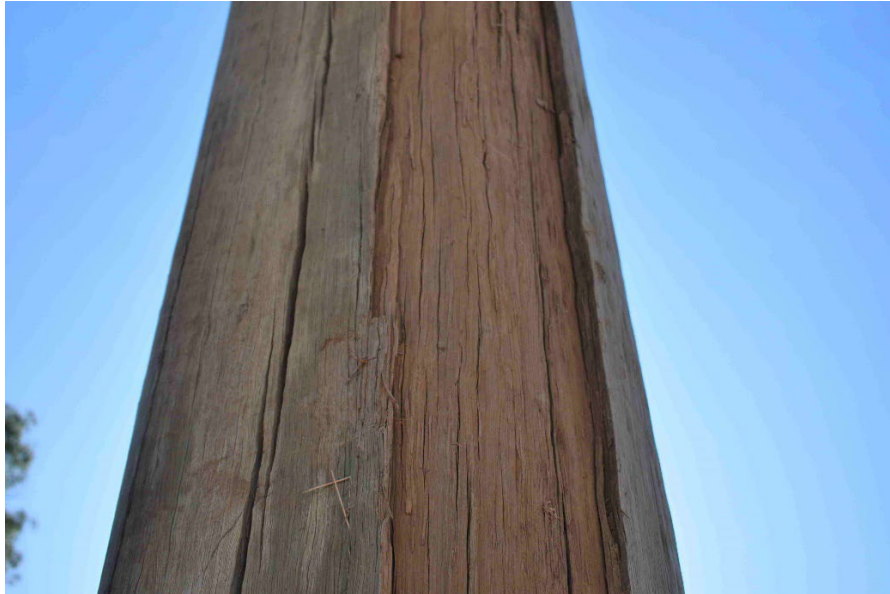
Figure 3-13 New pile with evidence of outer layer delamination (Source: FBE)

The typical defects at new piles included delamination of the outer layer of timber (see *Figure 3-13*), minor cracking and splitting (refer to *Figure 3-15*).

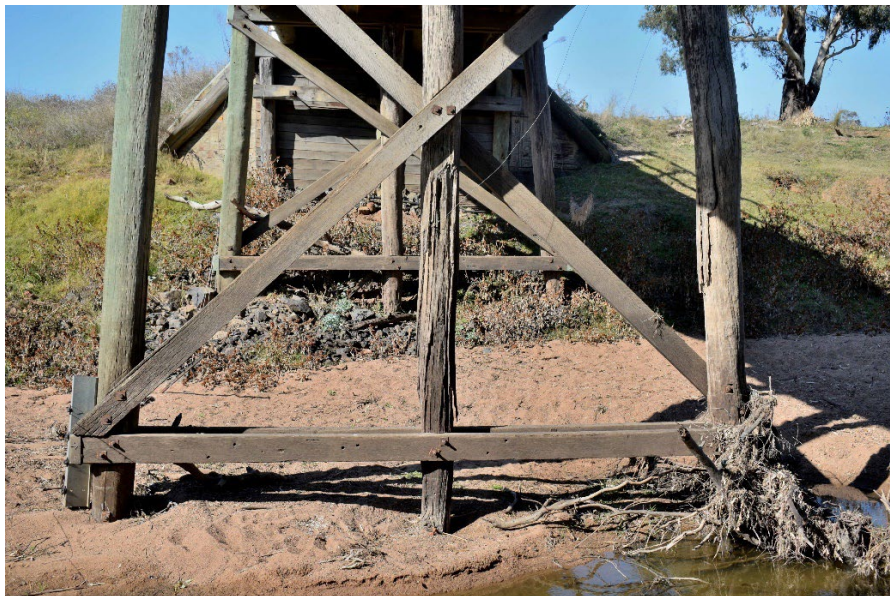
Figure 3-14 Typical deterioration of piles with section loss (Source: FBE)

The original piles were generally in poor to fair condition along the upper sections and were found to be deteriorating at the ground level with evidence of rotting leading to substantial section loss (see *Figure 3-14*). Due to reduction in pile cross section area, there are increased compression stresses in timber section due to permanent and live (vehicle) loads. It is, therefore, believed that piles affected by decay are critical elements in the bridge, would most likely fail in compression and should be treated as the highest risk. To manage the risk of unexpected pile failure, it is recommended to monitor the affected piles monthly. Monitoring would involve cleaning around selected piles, removing loose timber material, checking pile size (diameter or perimeter), assessing if there is any change in shape or geometry of the pile and making a photographic record.

TPIL	09	Routine	Decay of piles - monitor monthly	6	ea	High	2023-24

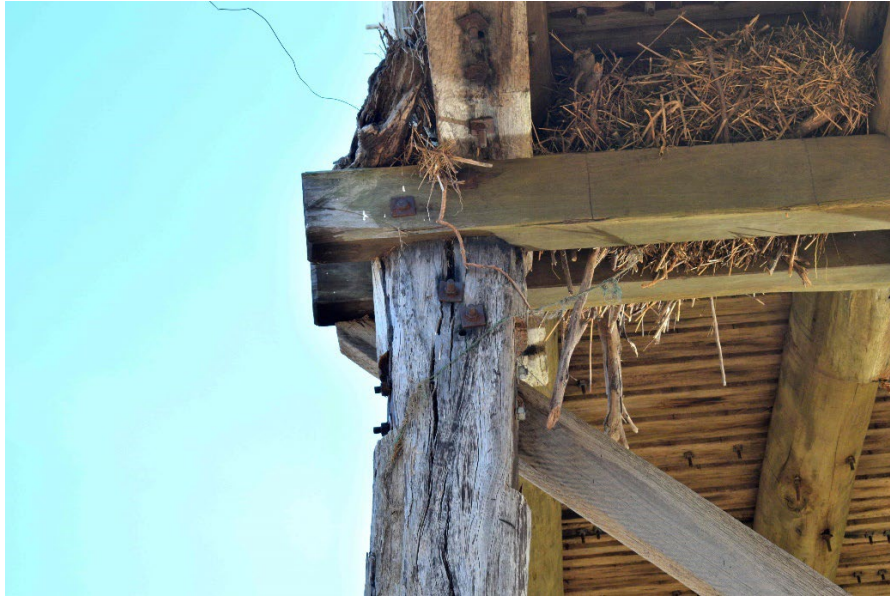
Figure 3-15 Splitting of the pile (Source: FBE)

Splitting was also observed at a number of piles, mainly at the top (see *Figure 3-15*).

Bridge Number and Name: 43673 Benolong Bridge							
Description: Four span timber girder bridge							
Inspector: Filip Tomczak							
Element Code	Defect Number	Activity	Inspectors Comment on Defect Severity and Required Action	Estimated Quantity	Unit	Repair Priority	Date Completion Required
TCHS	01	Routine	Removed flood debris from capwales	5	ea	Med	2024
TWBR	02	Major repair	Decay and insect infestation to brace at Pier 1 – recommended to be replaced	1	ea	High	2023
TLSH	03	Major repair	Longitudinal deck sheeting damaged with full section loss to be replaced	55	m ²	High	2023
TLSH	04	Minor repair	Numerous loose bolts to be tightened	50	%	Med	2023
TLSH	05	Routine	Debris in the carriageway - remove	15	m ²	Med	2023
TTDK	06	Major repair	Decayed transverse planks - replace	50	m ²	High	2023
TPIL	07	Routine	Remove flood debris build up at Piers 1, 2 and 3	3	ea	Med	2023
TPIL	08	Routine	Evidence of pile splitting at the top - monitor	2	ea	Med	2023

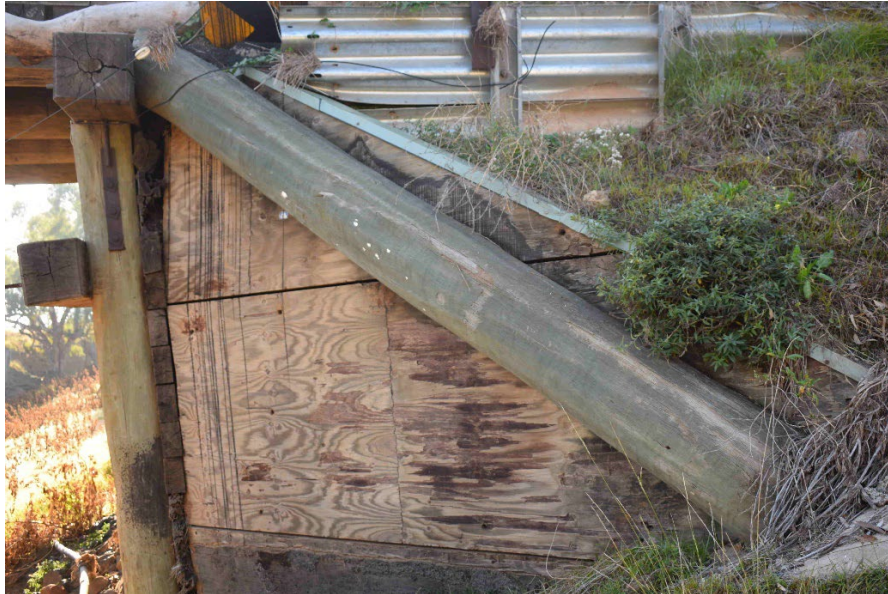
Figure 3-16 Abutment pile rotation (Source: FBE)

There was evidence of some decay of timber sheeting at Abutment B. Also, it was found that piles of Abutment B undergone some rotation in the past and ground anchor stabilisation was installed to prevent further movement (see *Figure 3-16*).

Note the abutment sheeting boards have been replaced by marine plywood sections.
