INFRASTRUCTURE, COMMUNITY AND RECREATION COMMITTEE

14 MAY 2018

Tree Report 77 Margaret Crescent

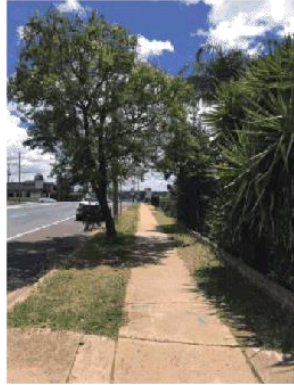
38 Whylandra Street

If this tree were to mechanically fail after excavation works it would pose a risk to traffic flow along Whylandra Street.

My suggestion is for the removal of this tree and replanting with suitable species in replacement according to Dubbo Regional Councils street tree register.

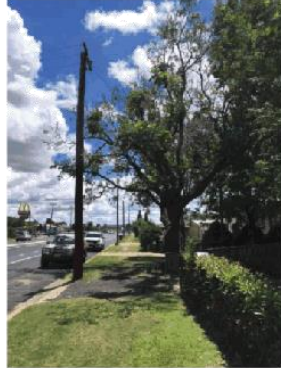
60 Whylandra Street

The location of this tree is also growing in between 2 incoming electrical services as well as a distribution power pole. If this tree were to mechanically fail after excavation works it would compromise power supply to houses and pose a risk to traffic flow along Whylandra Street.

My suggestion is for the removal of this tree and replacement of the tree after liaising with the property owner.

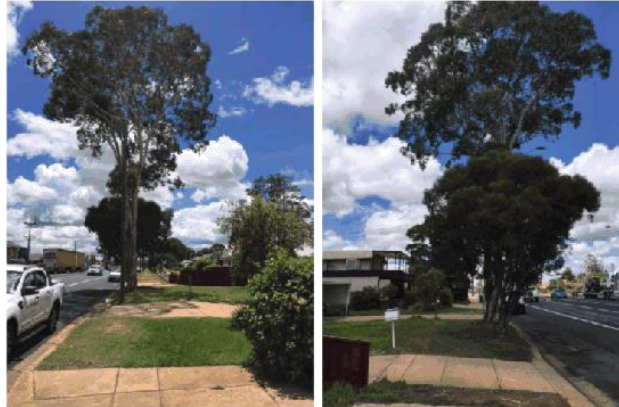
The location of the larger tree, Smooth Bark Eucalypt, is growing close to the proximity of 2 incoming services wires. If this tree were to mechanically fail after excavation works it would compromise power supply to houses and pose a risk to the traffic flow along Whylandra Street.

My suggestion is for the removal of both trees and replanting with suitable species in replacement according to Dubbo Regional Councils street tree register.

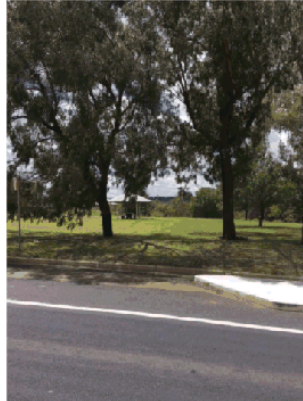
Sir Roden Cutler Park, Whylandra Street

If this tree were to mechanically fail it would pose a risk to the traffic flow along Whylandra Street.

My suggestion is for the removal of this tree and suitable tree as per Dubbo Regional Council's recommendation be planted in Sir Roden Cutler Park.

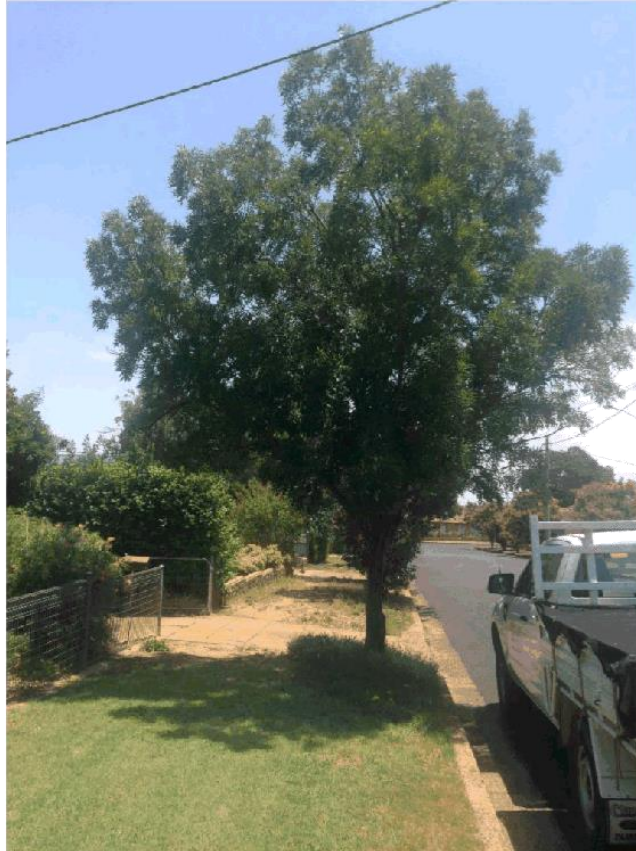
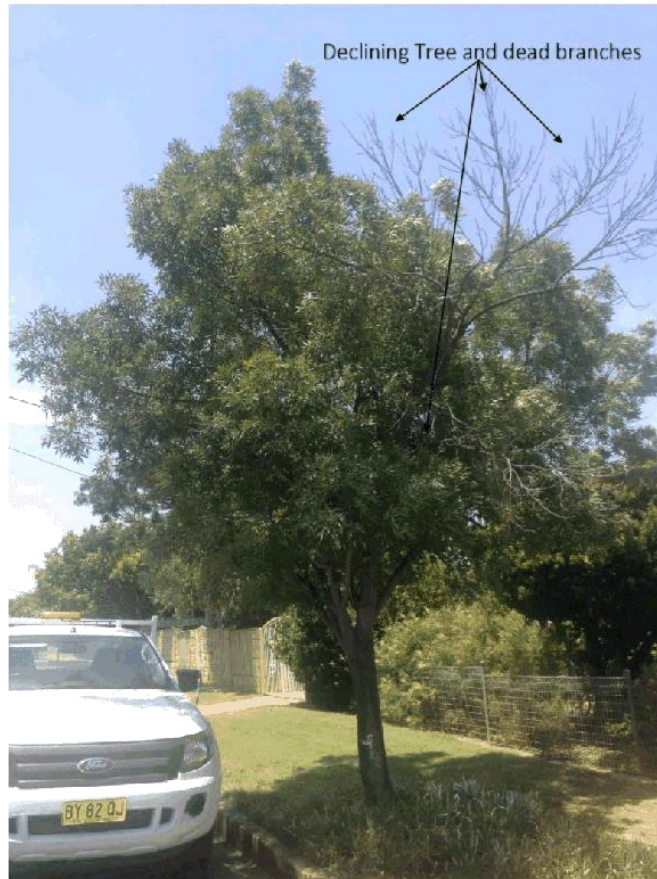
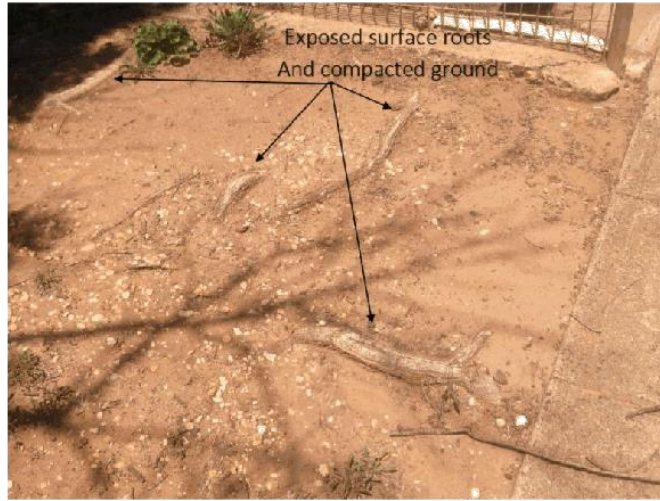
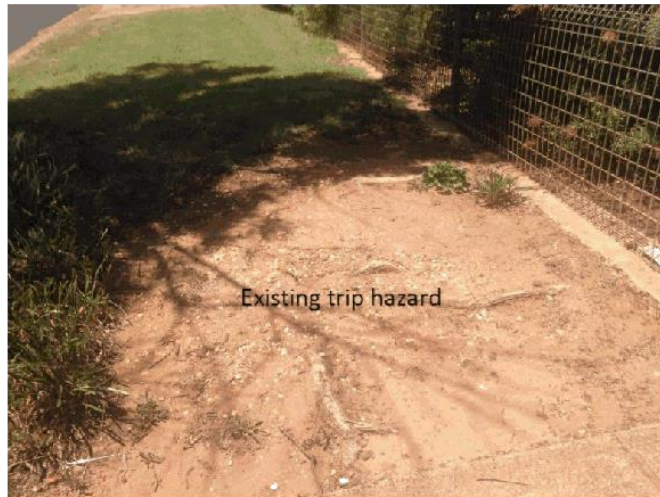
The tree is a semi-mature Claret ash - (*Fraxinus angustifolia* 'Raywood') in fair condition. The dimensions of the tree measured approximately 6.5 metres in height, a crown spread of 6 square metres, and a diameter breast height (DBH) of a 12.5 cm.

The tree is situated in a lawn area/footpath section north of the customer's residence, and approximately 2 metres east of the driveway. The kerb and guttering (K&G) is not damaged or lifting at this point in time and is situated approximately .5 metre north of the tree. There was no soil heaving/ground movement, or root plate lifting evident which indicates good stability in the ground.

A series of exposed tree roots on the footpath are travelling in the direction of the house and driveway, there is no turf growing in this section of the footpath. This is creating a trip hazard for the pedestrians in the area. Australia Post-delivery bikes continue to ride over the exposed roots and this places further compaction and stress on the root system and ultimately the tree. I believe root pruning and root barrier installation not to be suitable due to the close proximity of the exposed roots to the base of the tree. Pruning these roots may cause instability and further decline of the tree resulting in failure and/or death.

Due to the species and declining nature of the tree along with the unsuitability to root prune, the Lead Arborist recommends that the tree be removed and replaced with a Crepe myrtle - (*Lagerstroemia indica*). This tree species already dominates the street scape and the replacement will add to the continuity and aesthetics of the street tree avenue. The planting shall be done in accordance with Councils Street Tree Masterplan and Street Tree Planting Standard.

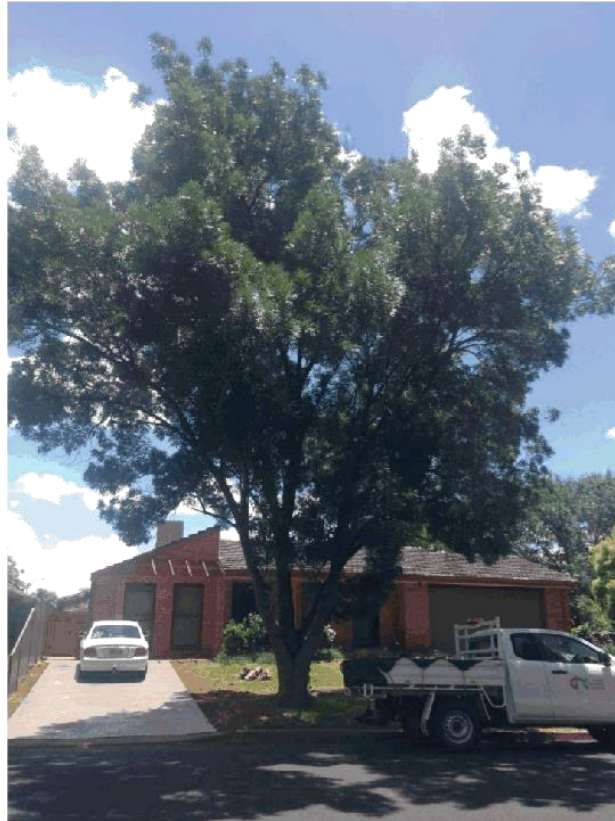
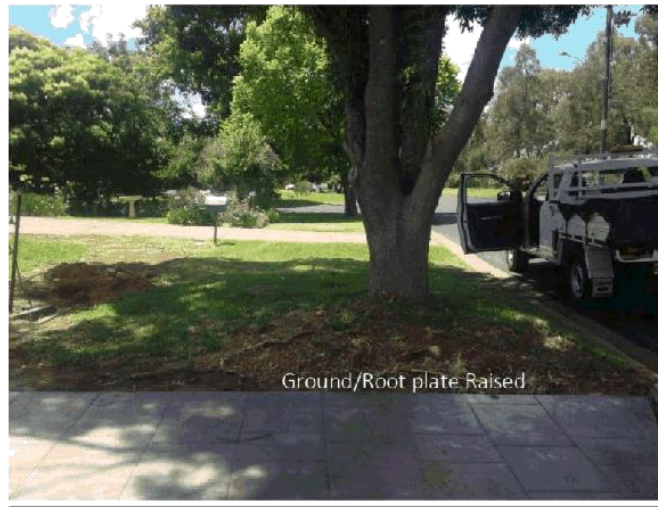
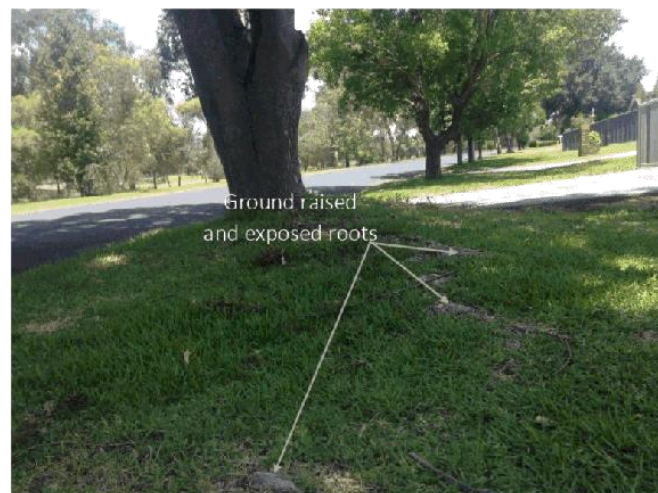
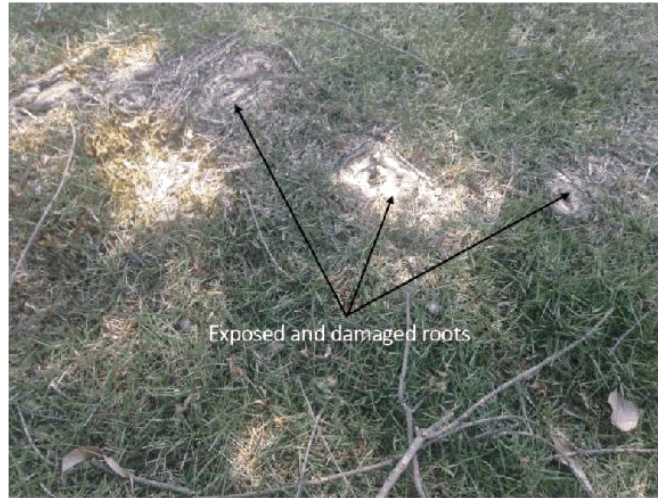
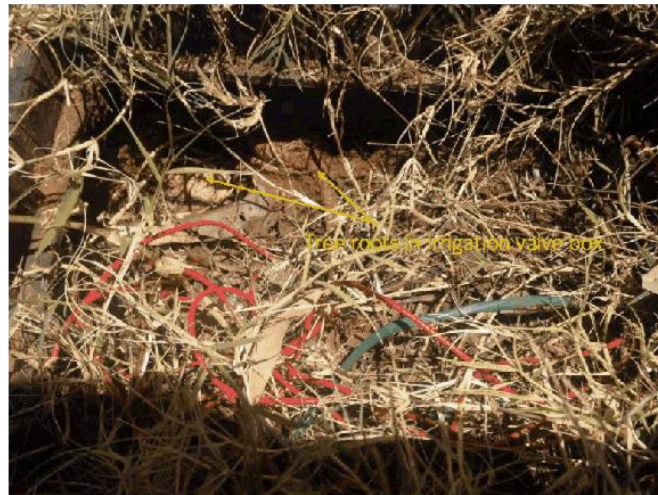
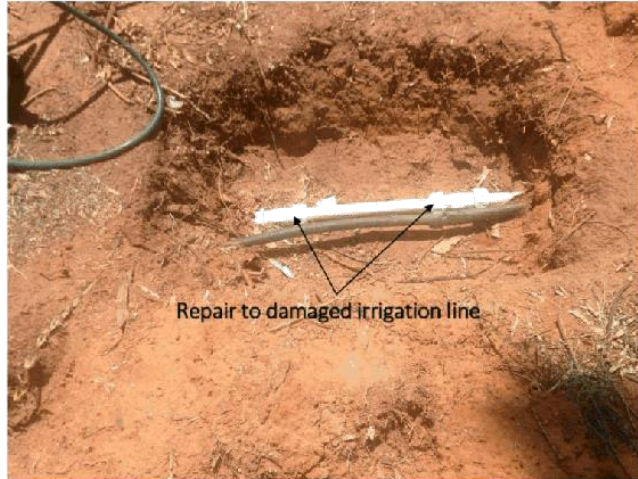
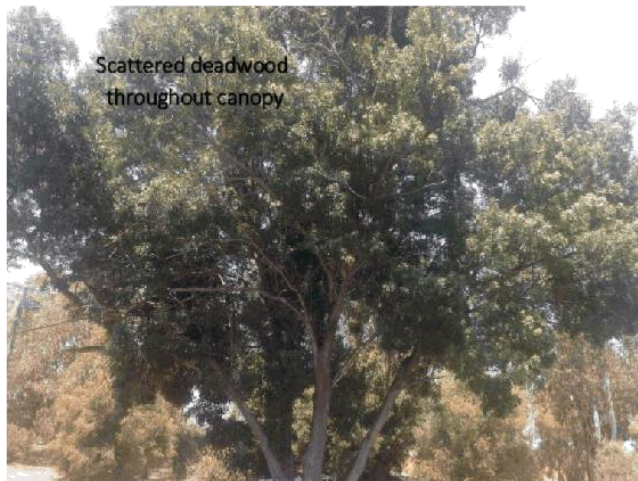
The tree is a multi-stemmed mature Claret ash - (*Fraxinus angustifolia*) 'Raywood', in good condition. The dimensions of the tree measured approximately 16 metres in height, a crown spread of 15 square metres, and a diameter breast height (DBH) of 57cm of 0.4m from ground level.

A series of exposed tree roots on the footpath are travelling in the direction of the property and driveway. These issues are creating a trip hazard for the pedestrians in the area, and the roots have been damaged as a result lawn mowers. The roots have also caused extensive damage to the resident's irrigation system, breaking pipework and entering the irrigation valve boxes within his property.

Root pruning and root barrier installation is considered not to be suitable due to the close proximity of the exposed roots to the base of the tree. Pruning to remove these roots may cause instability and further decline of the tree resulting in failure and/or death.

Due to the species, damage to property and the unsuitability to root prune, the Lead Arborist recommends that the tree be removed and replaced with a recommended species in accordance with Councils Street Tree Masterplan and Street Tree Planting Standard.

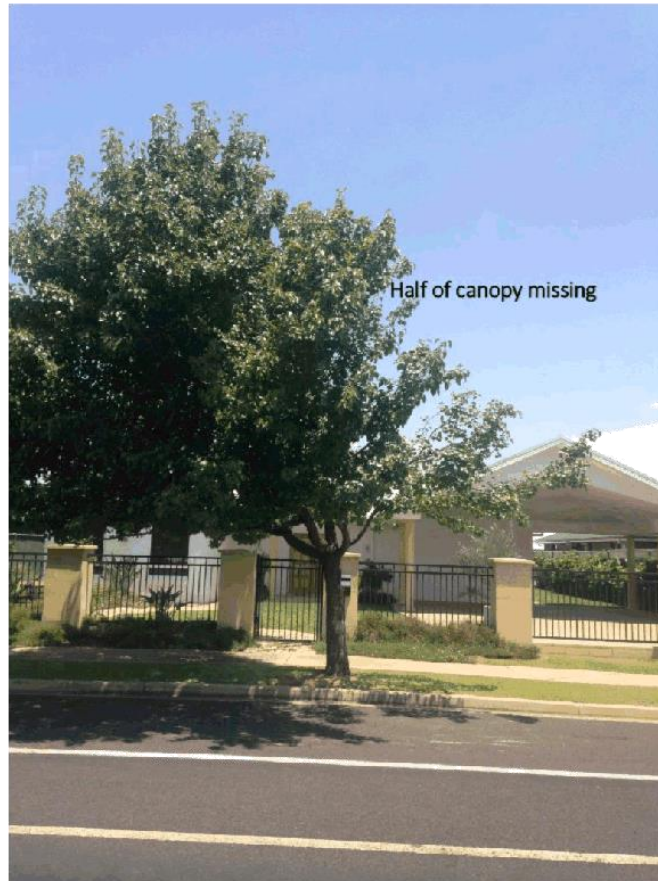
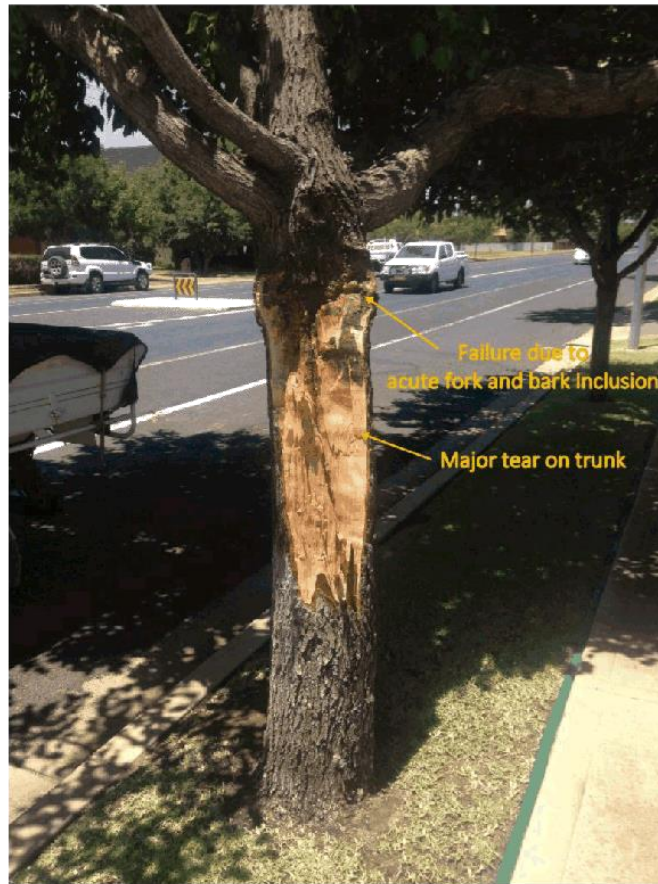
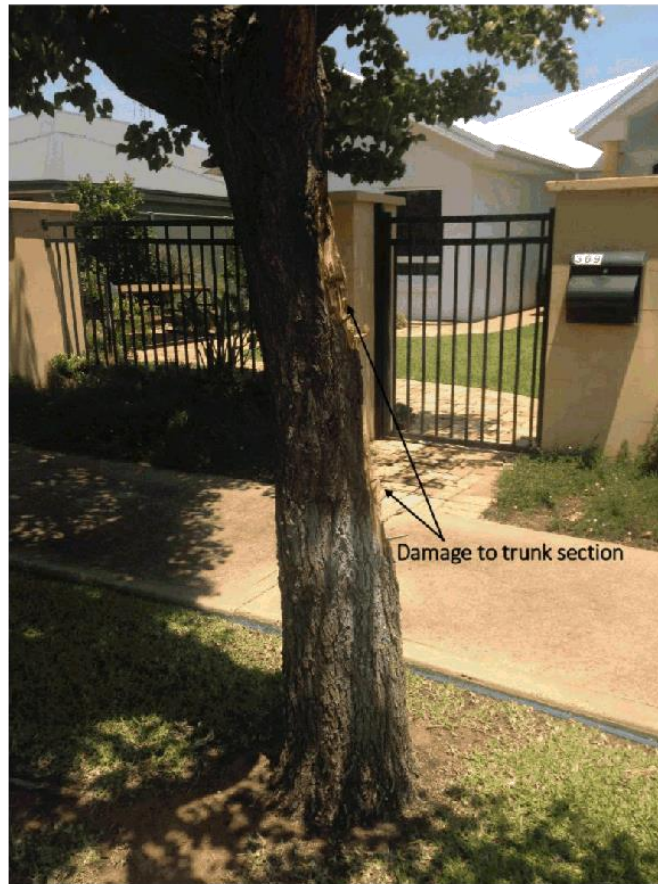
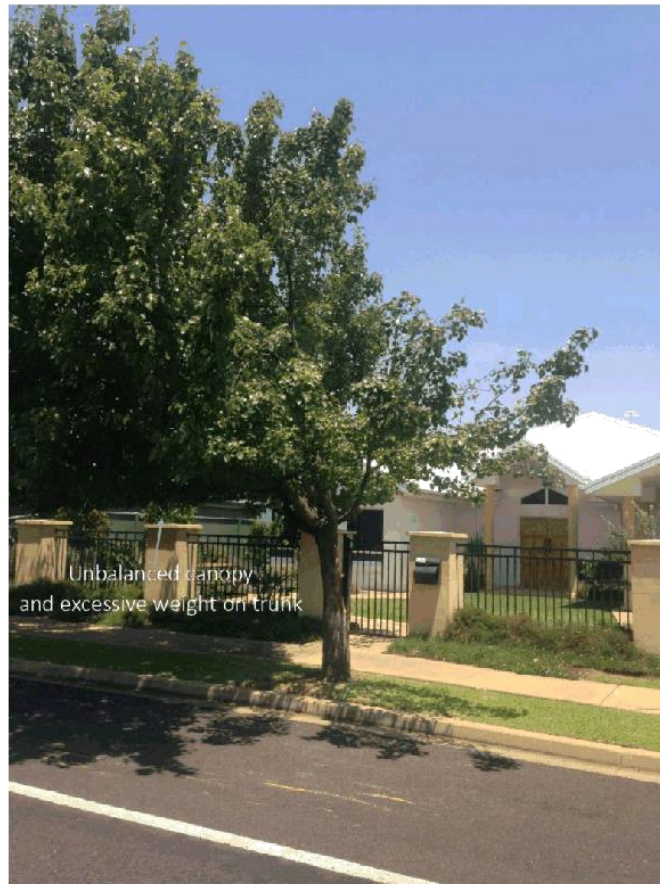
Tree Report 369 Macquarie Street

The tree is a semi-mature Manchurian pear (*Pyrus ussuriensis*). The remainder of the tree is in good condition at this point in time. The dimensions of the tree measured approximately 6.5m in height, a crown spread of 10m², and a diameter breast height (DBH) of a 28cm.

A couple of exposed surface roots were visible but are not considered a trip hazard at this point in time. No soil heaving or root plate lifting was evident which indicates the tree is stable in the ground.

No pests or diseases were evident on any part of the tree at the time of my inspection. Only half of the tree canopy remains due to a previous failure, and this has resulted in major damage to the trunk section, due to this the structure of the tree is now classed as poor. Damage like this has decreased the structural integrity of the tree and will allow pest and/or disease to enter into that section of the trunk. The normal response to healing and wound closure will not be adequate in such a severe tear/wound. The tree now has an unbalanced canopy and poor structure which may result in further failure in the near future.

The Lead Arborist recommends that the remainder of the tree be removed and another of the same species be planted nearby in a suitable timeframe as per the Street Tree Masterplan and Street Tree Planting Standard.

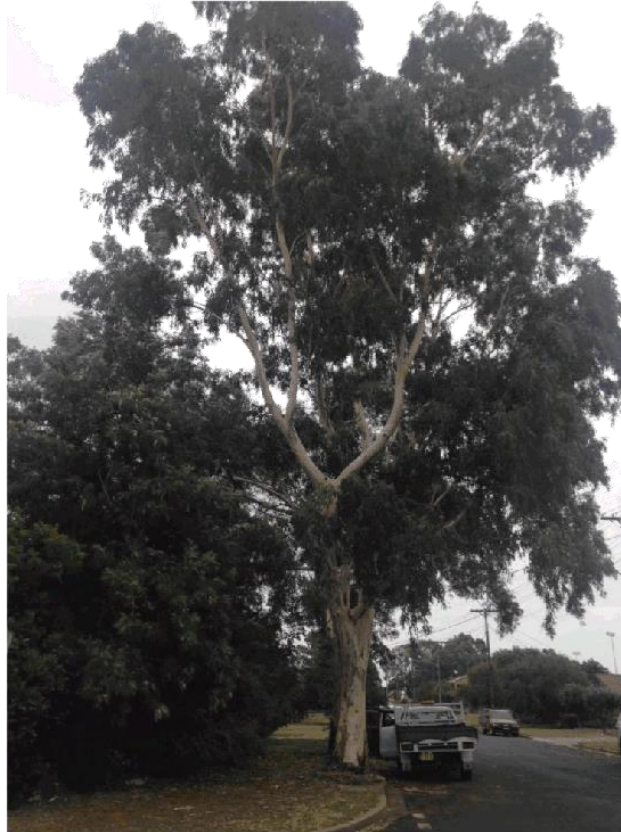
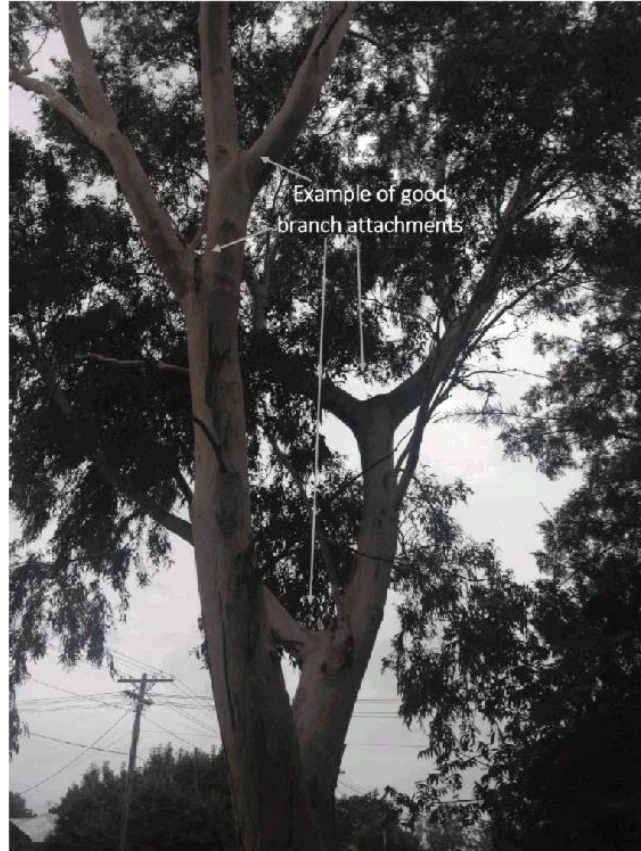
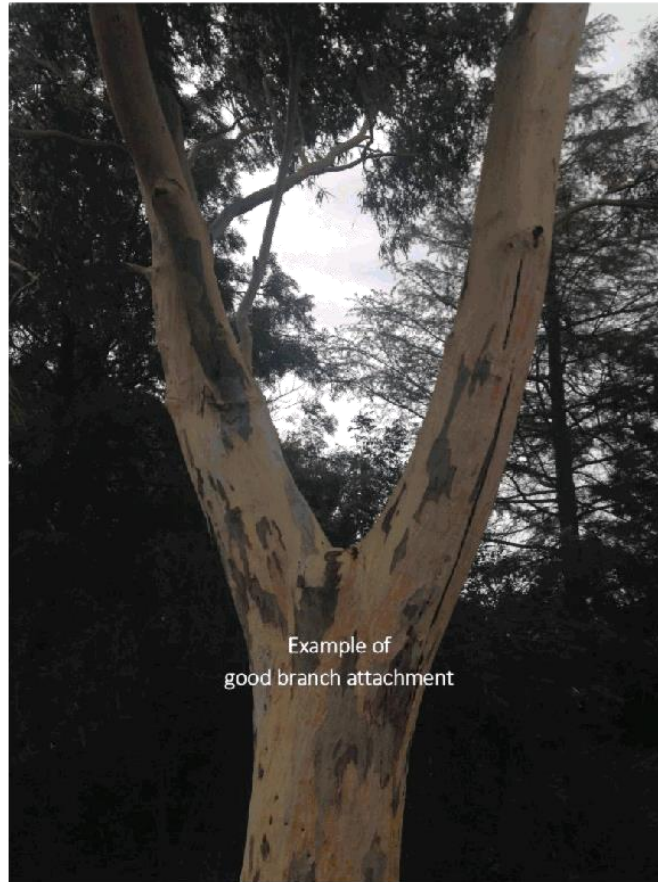
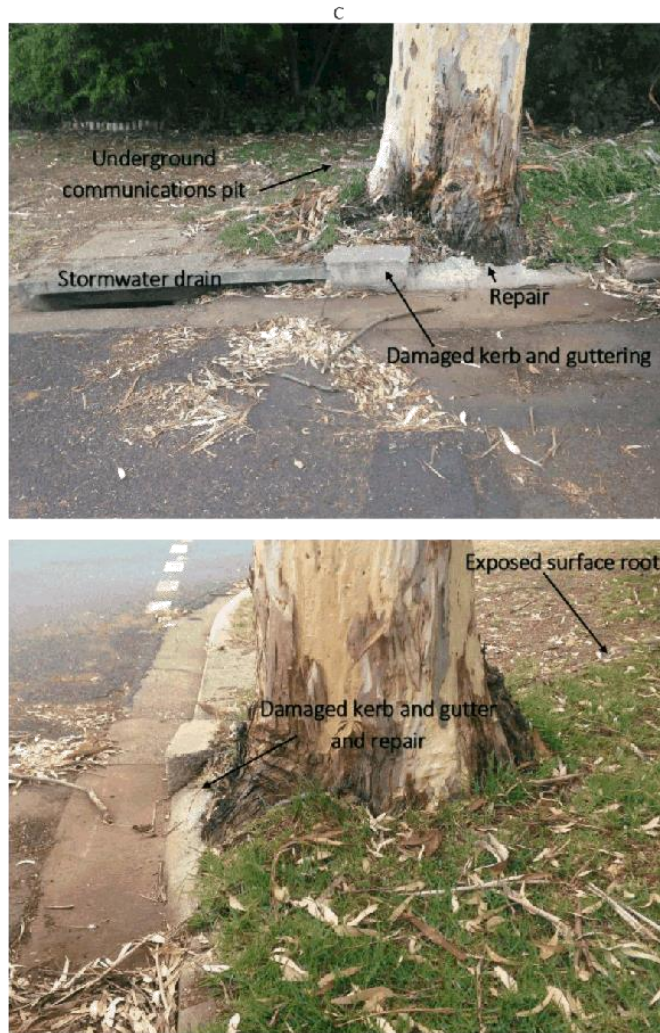
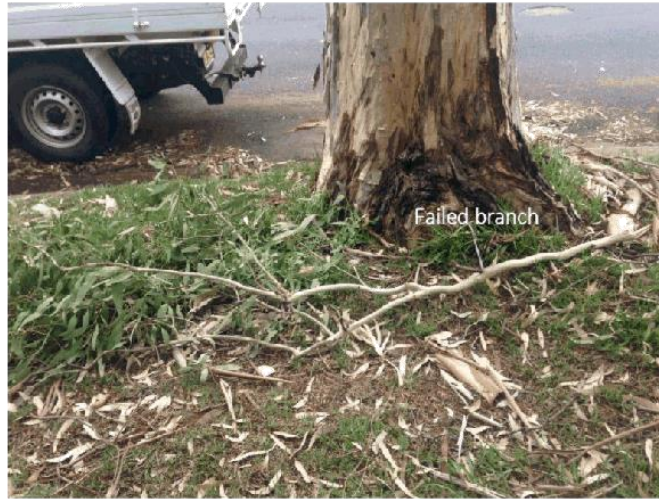
Tree Report 19 Opal Street

The tree is a mature Blakelys Red gum - (*Eucalyptus blakelyi*) in good condition with good canopy cover. The dimensions of the tree measured are as follows: Height - Approximately 29m, Crown Spread - Approximately 17m², Diameter Breast Height (DBH) 74cm measured at 1.4m from ground level.

The branch attachments appear to be very good, so they are less likely to fail under normal conditions. Wound/healing wood from past pruning cuts and failures appears to be good as well, and this indicates that the tree is still showing signs of vigour and vitality.

The tree is situated in a grassed footpath section north of the customer's residence, and approximately 10m west of the Diamond/Opal Street intersection. A stormwater drain is located directly east of the tree. The kerb and guttering (K&G) is situated against the base of the tree and has been lifted and shifted sideways and damaged, this has been roughly repaired up against the buttress or base of the tree.

There is no ground movement or soil heaving which indicates the tree is stable in the ground therefore whole tree failure is very unlikely.

The Lead Arborist recommends that the tree be pruned of deadwood and an aerial inspection of the canopy be implemented to confirm on-ground assessment of the tree. The tree to be retained unless further assessment indicates otherwise.

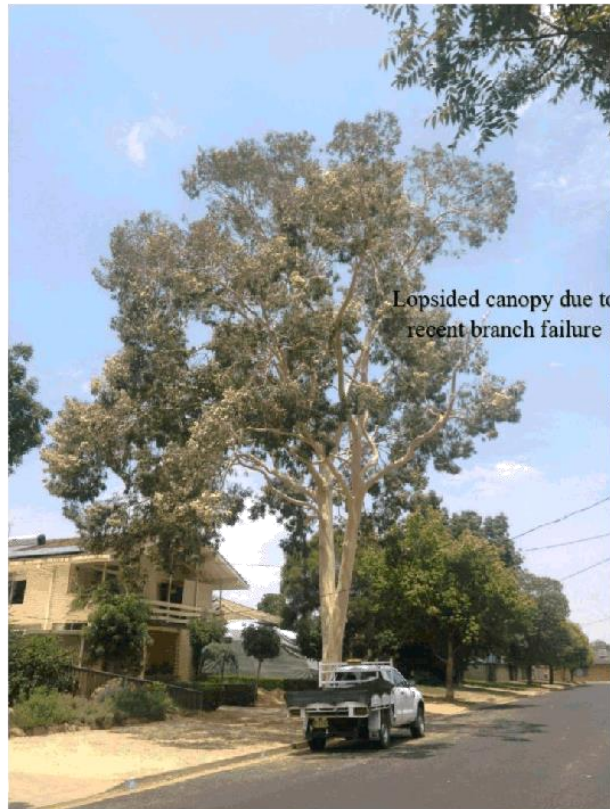
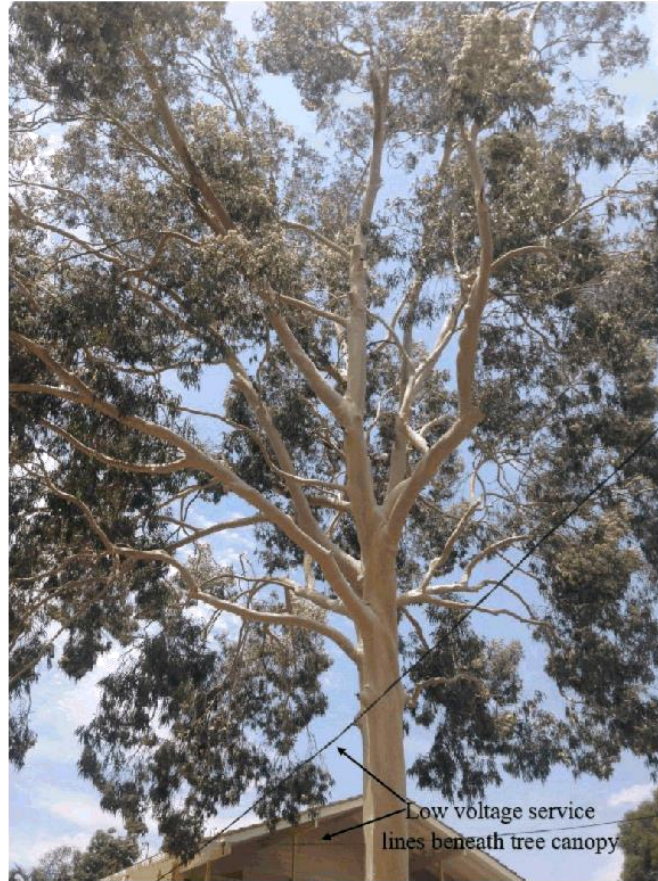
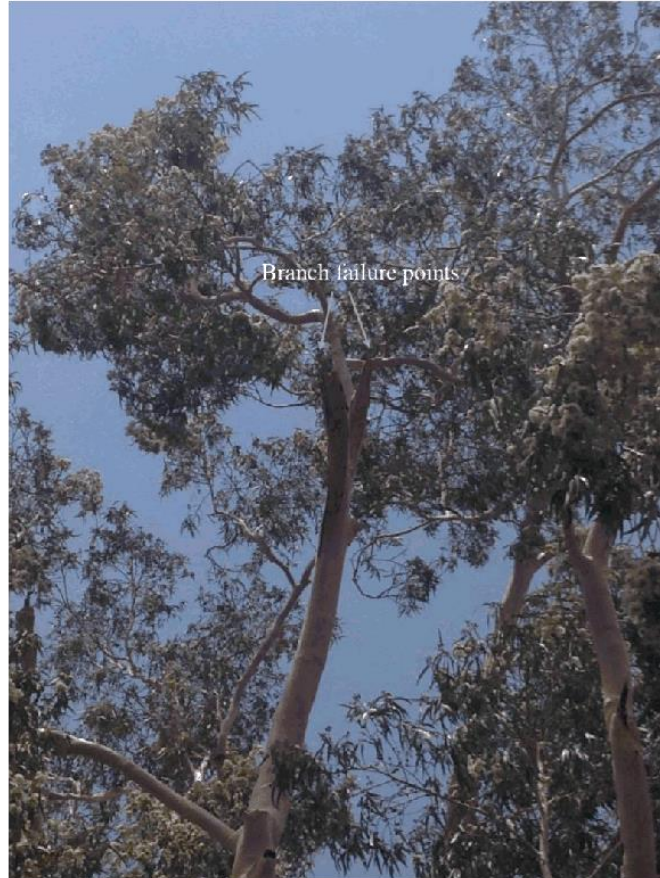
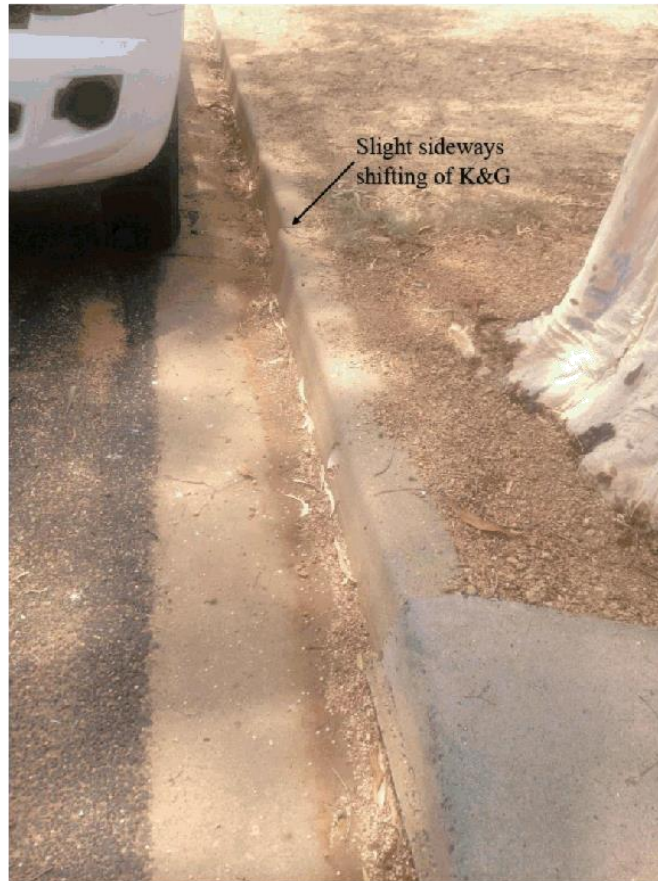
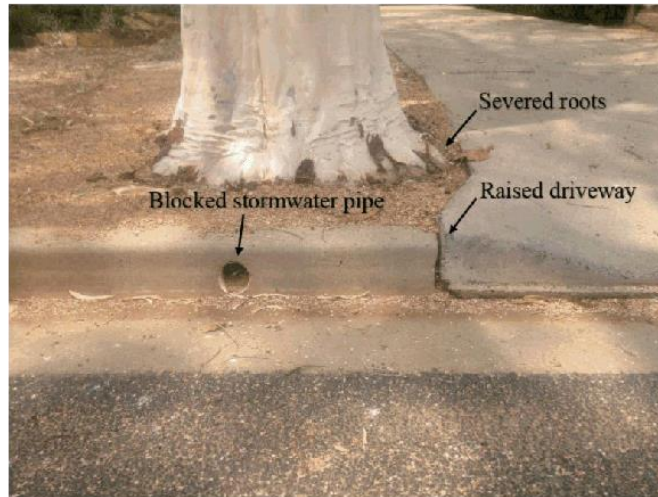
Tree Report 16-18 Gundarra Street

The tree is a mature Lemon scented gum - (*Corymbia citriodora*) in good condition. The dimensions of the tree measured approximately 27m in height, a crown spread of 18m², and a diameter breast height (DBH) of 65cm measured at 1.4m from ground level.

The tree is displaying a small amount of deadwood branches in the middle part of the canopy. These branches have a diameter of approximately 2cm. Several small broken branches are also lodged in the tree canopy and these range in size from 1 to 2 cm. These are small branches which would have a very low impact if they fell from the tree.

One surface root is exposed on the K&G side of the tree, other roots have been severed close to the trunk on the driveway side of the tree, by who I'm unaware. There is no ground movement or soil heaving which indicates the tree is stable in the ground and the likelihood of whole tree failure is very low.

The tree has had more than a few branch failures over recent years, the failure points were observed while inspecting the tree. The tree now has a lopsided canopy and fair structure due to recent failures mainly on the road side or western side of the tree.

The Lead Arborist recommends that the tree be retained and pruned of deadwood, with previous failure points pruned back to the appropriate location. The small hanging branches should also be removed. Selective pruning of branches on the house side will also maintain an even canopy and help reduce further failures in the future.

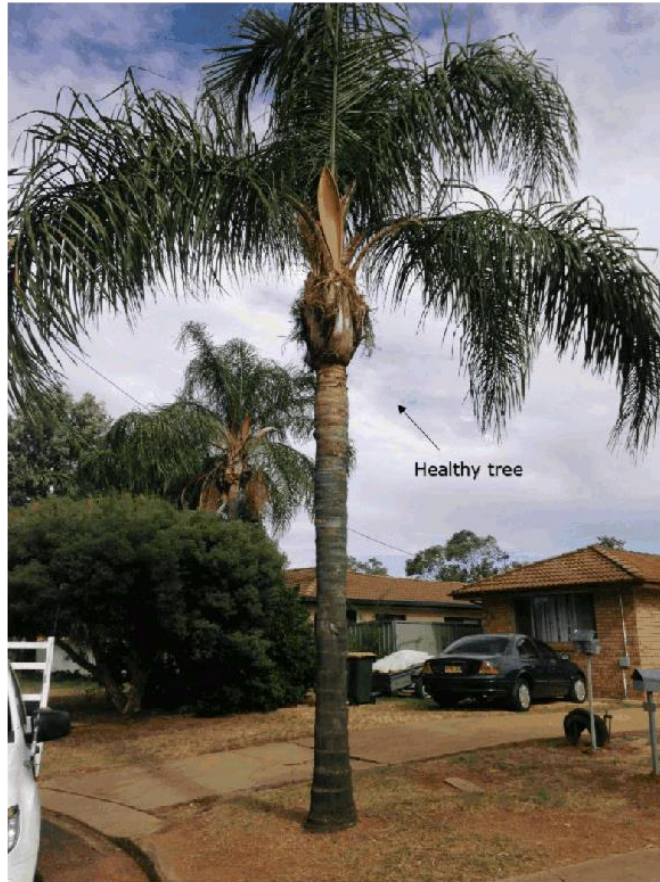
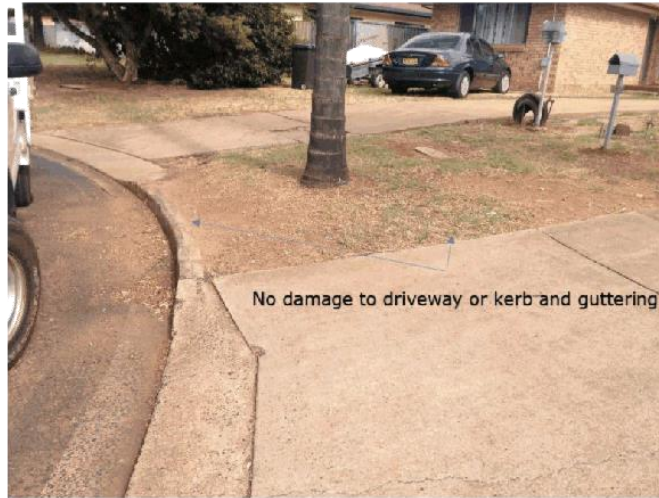
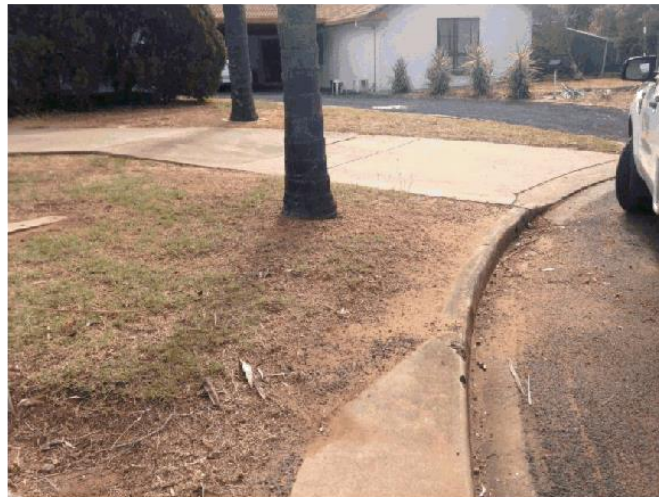
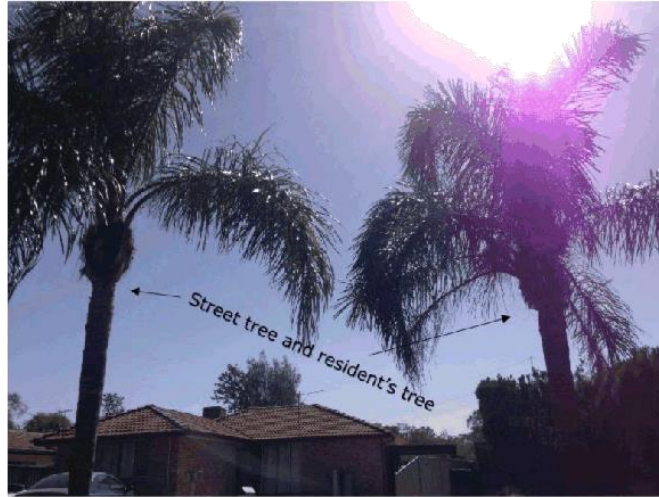
Tree Report 3 Newcombe Court

The tree is a mature Cocos palm - (*Syagrus romanzoffiana*) in good condition. The dimensions of the tree measured approximately 9.5m in height, a crown spread of 7m², and a diameter breast height (DBH) of 27.5cm.

The tree is situated on the footpath section south of the customer's residence, and approximately 1.4m west of the driveway. The kerb and guttering (K&G) is not damaged or lifting at this point in time and is situated approximately 1m south of the palm tree. A communications pit is also located and undamaged 1.6m to the north. There was no soil heaving/ground movement, or root plate lifting evident which indicates good stability in the ground.

The tree is in good condition and has been previously pruned, removing the berries to alleviate the customers concerns. Until the tree itself declines and/or becomes unsafe I recommend the tree be retained.
