INFRASTRUCTURE, PLANNING AND ENVIRONMENT COMMITTEE

13 JULY 2023

REPORT: Benolong Bridge - Temporary Load Limit Due to Timber Bridge Condition

Dubbo Regional Council
Benolong Bridge
Level 2 Inspection Report

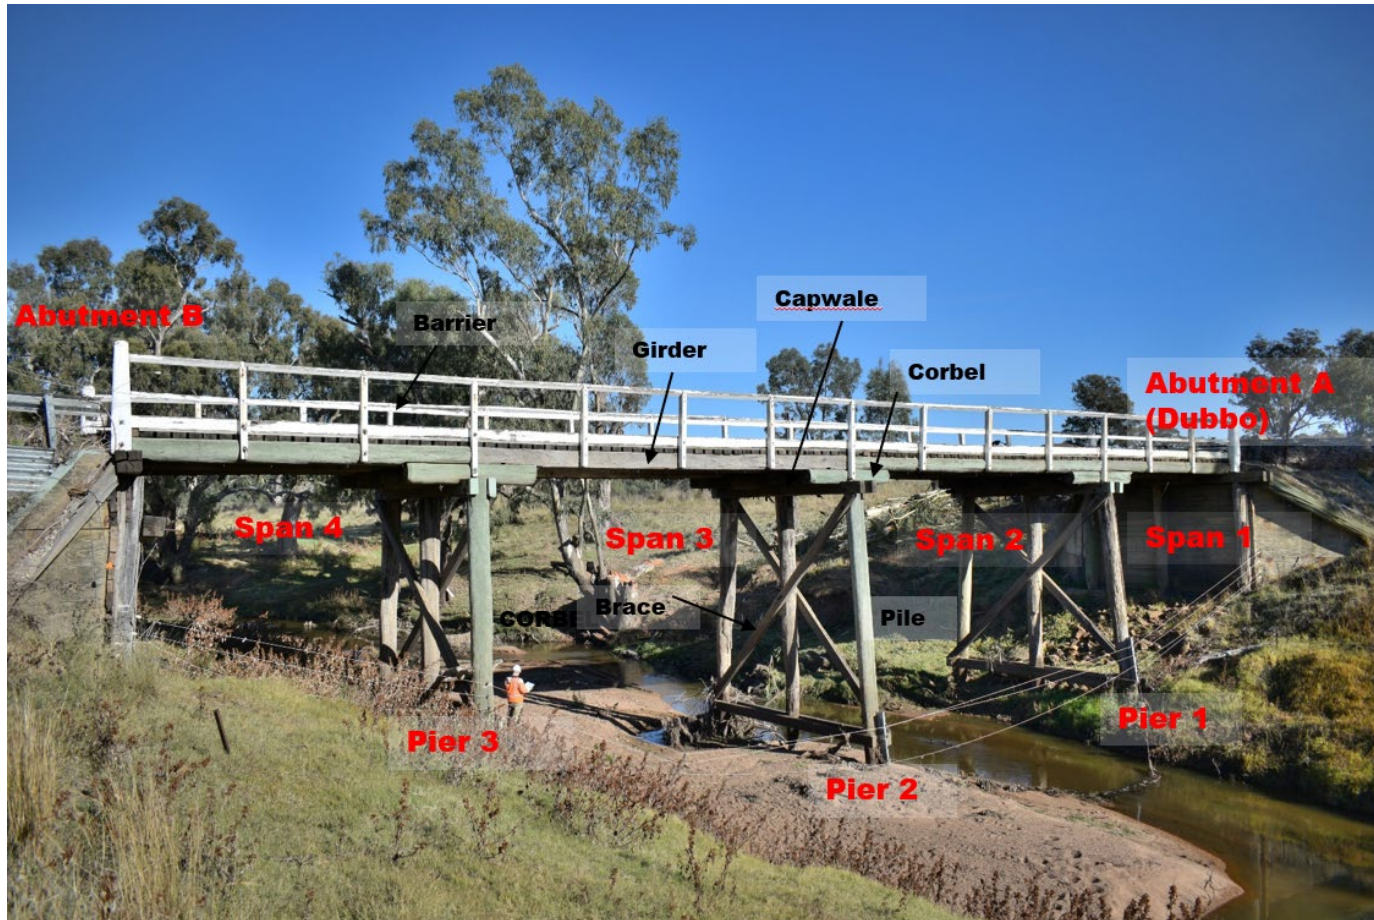
Figure 2-1 Benolong Bridge elevation (Source: FBE)

Each span of the superstructure is formed of 3 timber girders, seated on timber corbels and are topped with transverse timber deck planks and longitudinal running planks. It appears that most of the girders, corbels and piles have been replaced in the past. The remaining original girders and corbels have square cross section, while new girders and corbels are circular.
